**Single Family House Fire**  
**May 4, 2011**  
**11221 Ashley Drive**  
**Box Area 5-13**

## Post Incident Analysis for 11221 Ashley Drive

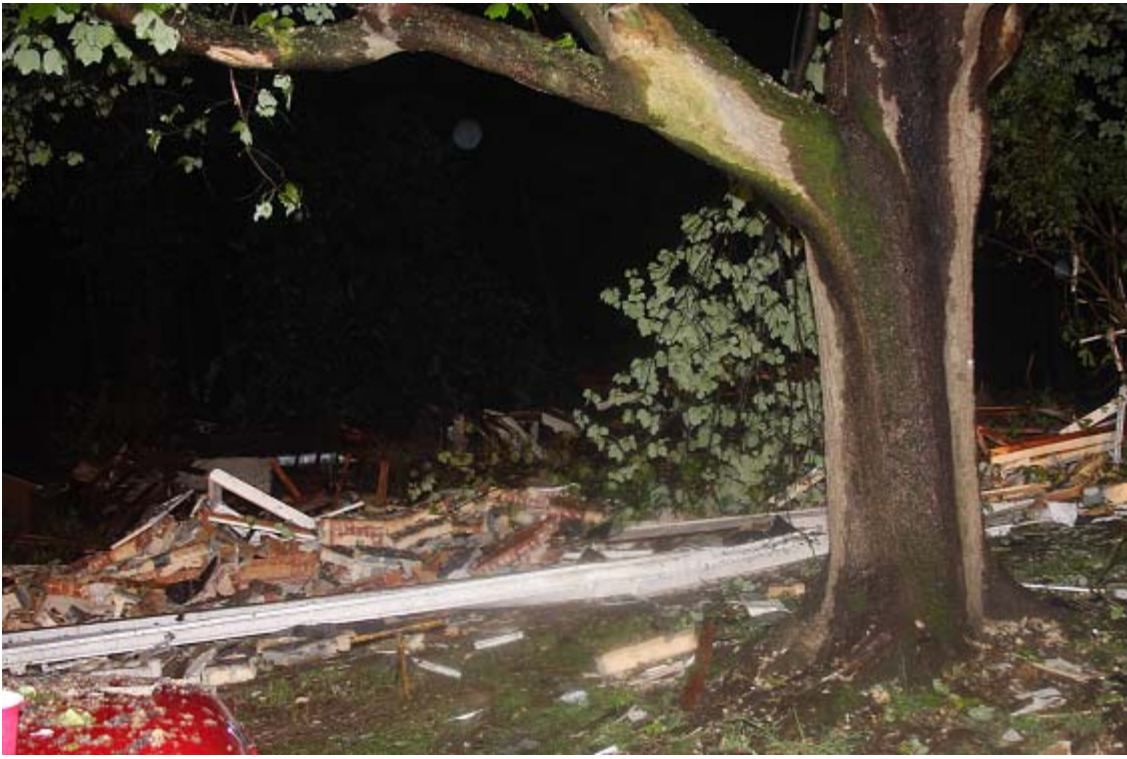
- Initial report of house fire with two people trapped
- House explosion
- Gas fed fire
- Five houses damaged
- Two occupants ejected/seriously injured from home in explosion
- Occupants replaced gas clothes dryer approximately one day earlier

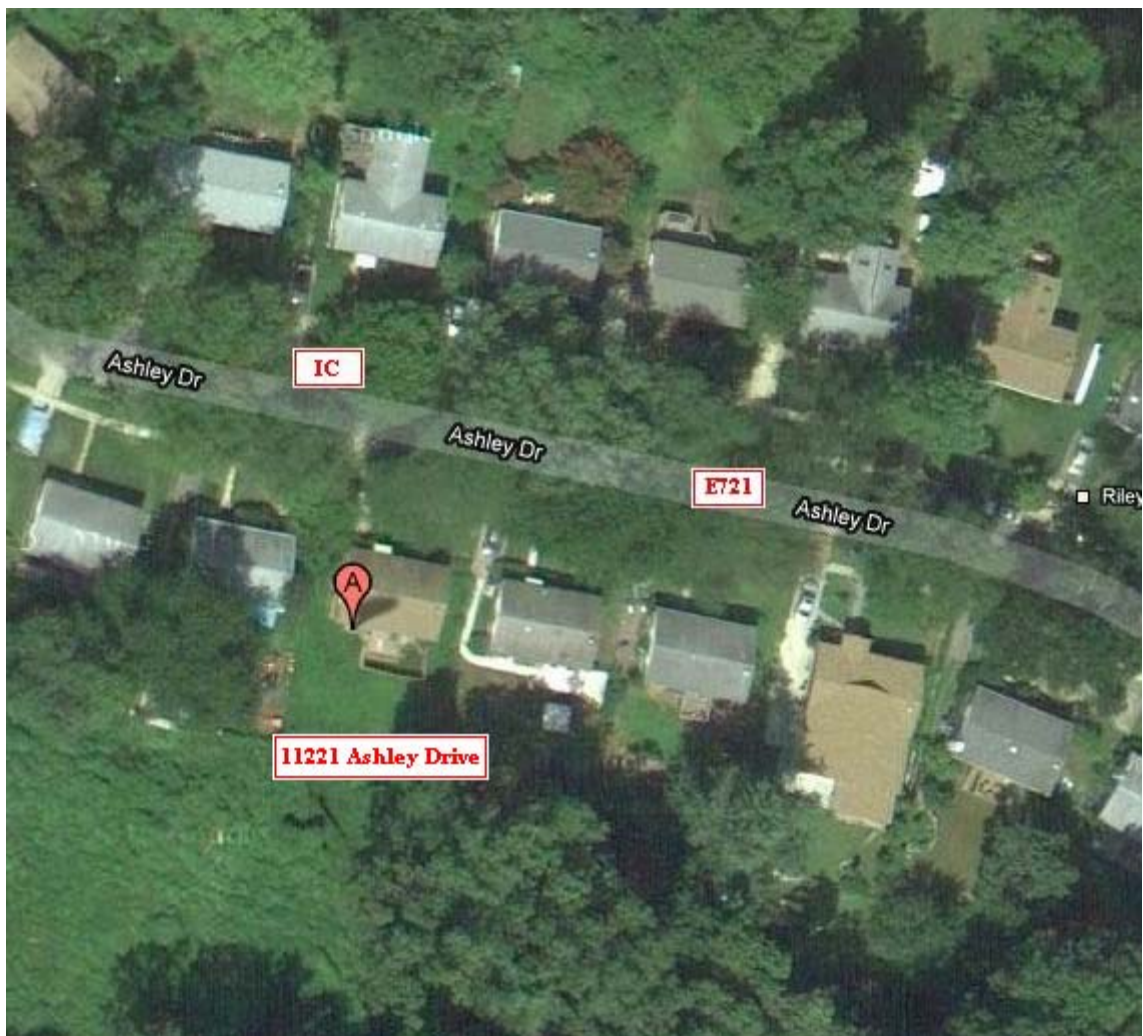
### Site & Structure Layout

- Single family home, middle of the block, with main entrance facing side Alpha.
- House was completely destroyed upon arrival of F/R units.
- Hydrants that could be accessed with straight lays were 11220 & 11206 Ashley Drive.
- Building construction of homes in the area is of brick and block Type 5 construction with wood frame interior walls, floors, and roof.
- House occupants had moved in four days prior to incident.
- Occupant had attempted to change gas powered clothes dryer in basement less than 24-hours prior to incident.
